| SYSTEM | PROTEUS PRO-COLD® PRO-JOINT TAPE |
| PROJECT TYPE | REFURBISHMENT |
| APPLICATION | PITCHED ROOF |

**PROJECT OVERVIEW**

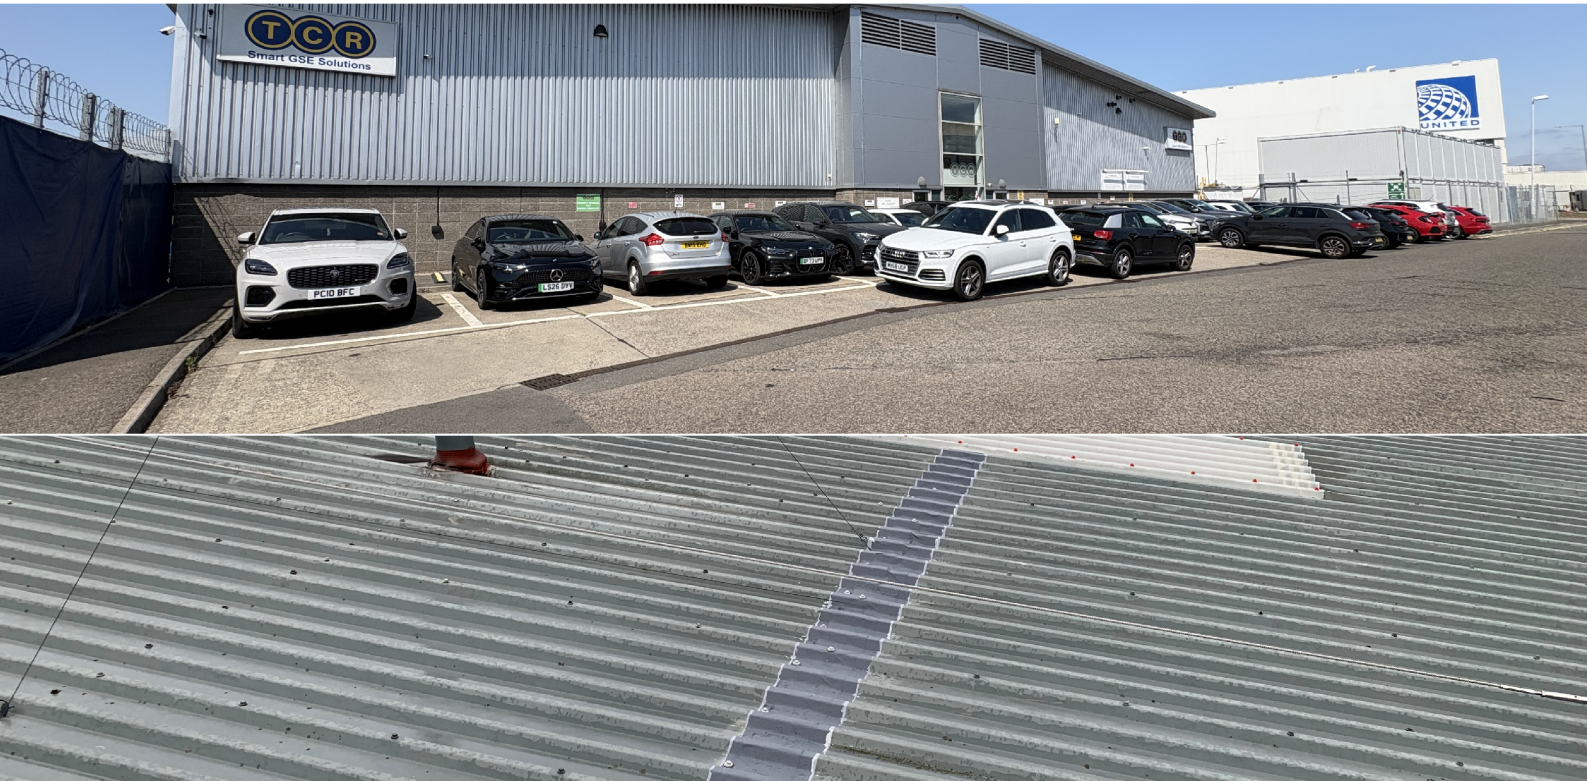
Heathrow is the busiest airport in Europe, and behind its terminals sits an estate of operational buildings that keep the airport running. Proteus Waterproofing already protects a number of roofs across Heathrow, and as part of this ongoing programme, Building 16265 required attention to its pitched metal roof, where the sheets were showing cut-edge corrosion.

Where profiled metal sheets are cut and lapped, the protective coating stops at the cut edge, leaving the steel exposed. Corrosion starting there can creep back beneath the coating and along the laps, leading to leaks and eventually sheet replacement. The corroded edges were wire brushed to remove the rust, Pro-Joint Tape installed across the affected edges and laps, and Proteus Pro-Cold® applied over the top to seal and protect them — following the profile of the sheets and curing to a seamless finish across each repair.

By treating the cut edges in place, the roof sheets were protected without the cost or disruption of replacing them, extending the service life of the existing roof. Once cured, Proteus Pro-Cold® forms a seamless, fully adhered, elastomeric membrane with UV stability. It is UK manufactured and BBA certified — supporting the issue of a guarantee, and adding Building 16265 to the roofs Proteus Waterproofing protects across Heathrow Airport.
