Making an entrance at Kingston House North

Project Brief

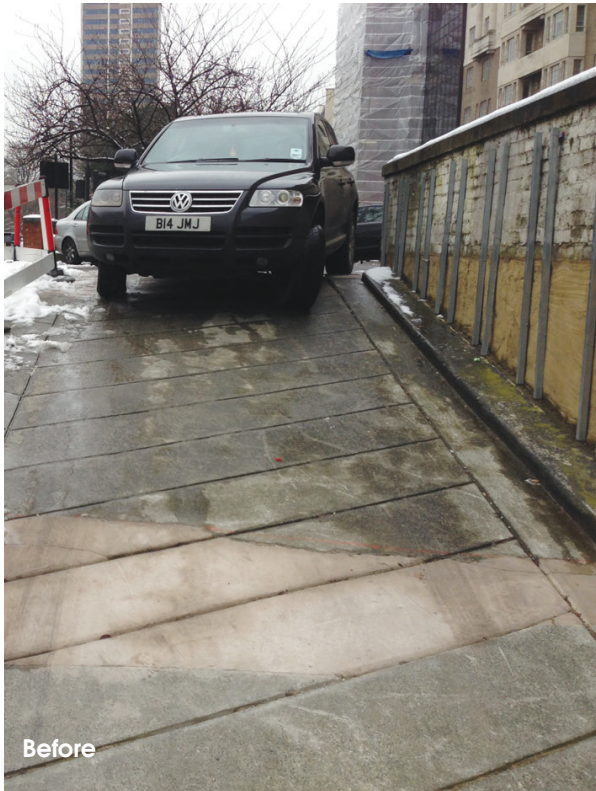
Before

When the existing concrete surface of a basement car park in Princes Gate, London, started to show signs of spalling and general wear and tear – the surface became slippery to both vehicular and pedestrian access during wet and cold conditions.

Where concrete degradation was most advanced, these areas were repaired prior to the application of Proteus Deckmaster HFS.

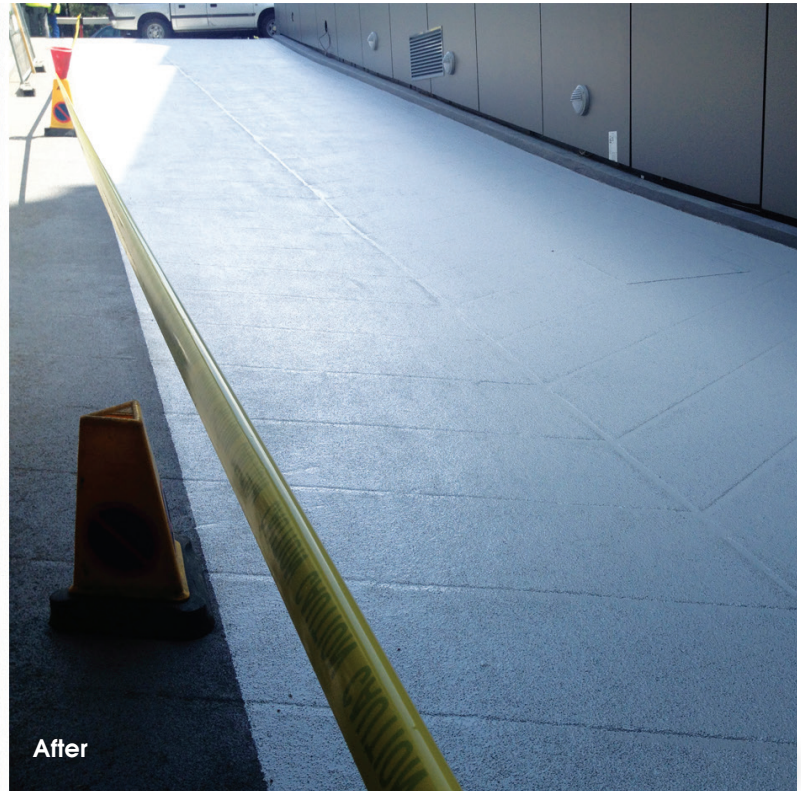
After

Sealed with an ultra violet stable top coat, the deck was finished in two separate colours to provide a clear distinction between the vehicle traffic aisle and pedestrian walkways.

The Deckmaster HFS System fitted the bill perfectly by combining a fast-curing application, better anti-slip properties and an aesthetically appealing finish.

Binding the fast curing system with bauxite aggregate provided a slip-resistant finish that would not only stand the test of time but meet the challenges presented by a highly trafficked site.
