# Millom Infant School, Cumbria

## **Project Overview**

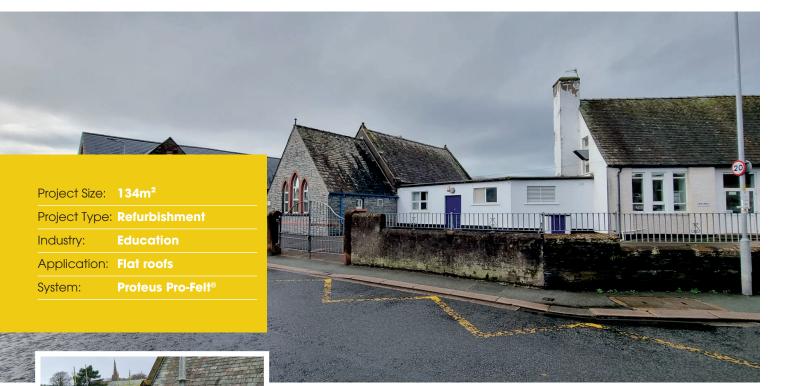
Located in Cumbria, Millom Infant School was experiencing problems with an ageing roof. Classrooms remained unused due to damp and mould growth which was affecting the day to day running of the school. Proteus Waterproofing® were approached to provide a long-term waterproofing solution which would allow the school to run with a full capacity of classrooms.

The existing roof structure was a horseshoe design with a gutter running around the inside edge. The insulation scheme was tapered to encourage the water to fall into the centre. A vapour control layer was also used to prevent moisture from passing through to the building's structure.

• Complex Details: Due to the Victorian construction, there were adjacent walls with low cill details and pitched slate roofs finishing close to the flat roof. Thinner insulation boards were used to abut these areas allowing for adequate heights from the top of the board to the underside of the tiles and cills. Perimeter upstands were low in height, so these had to be raised to allow for the height of the tapered insulation design. The upstands were then finished with new fascia boards and a GRP edge trim.

The roof was fully stripped back to the original concrete deck and a new build up insulated felt system installed to conform to current regulations.
